# Flood conditions: Fogera and Dembia floodplains, Ethiopia, August 18 2013

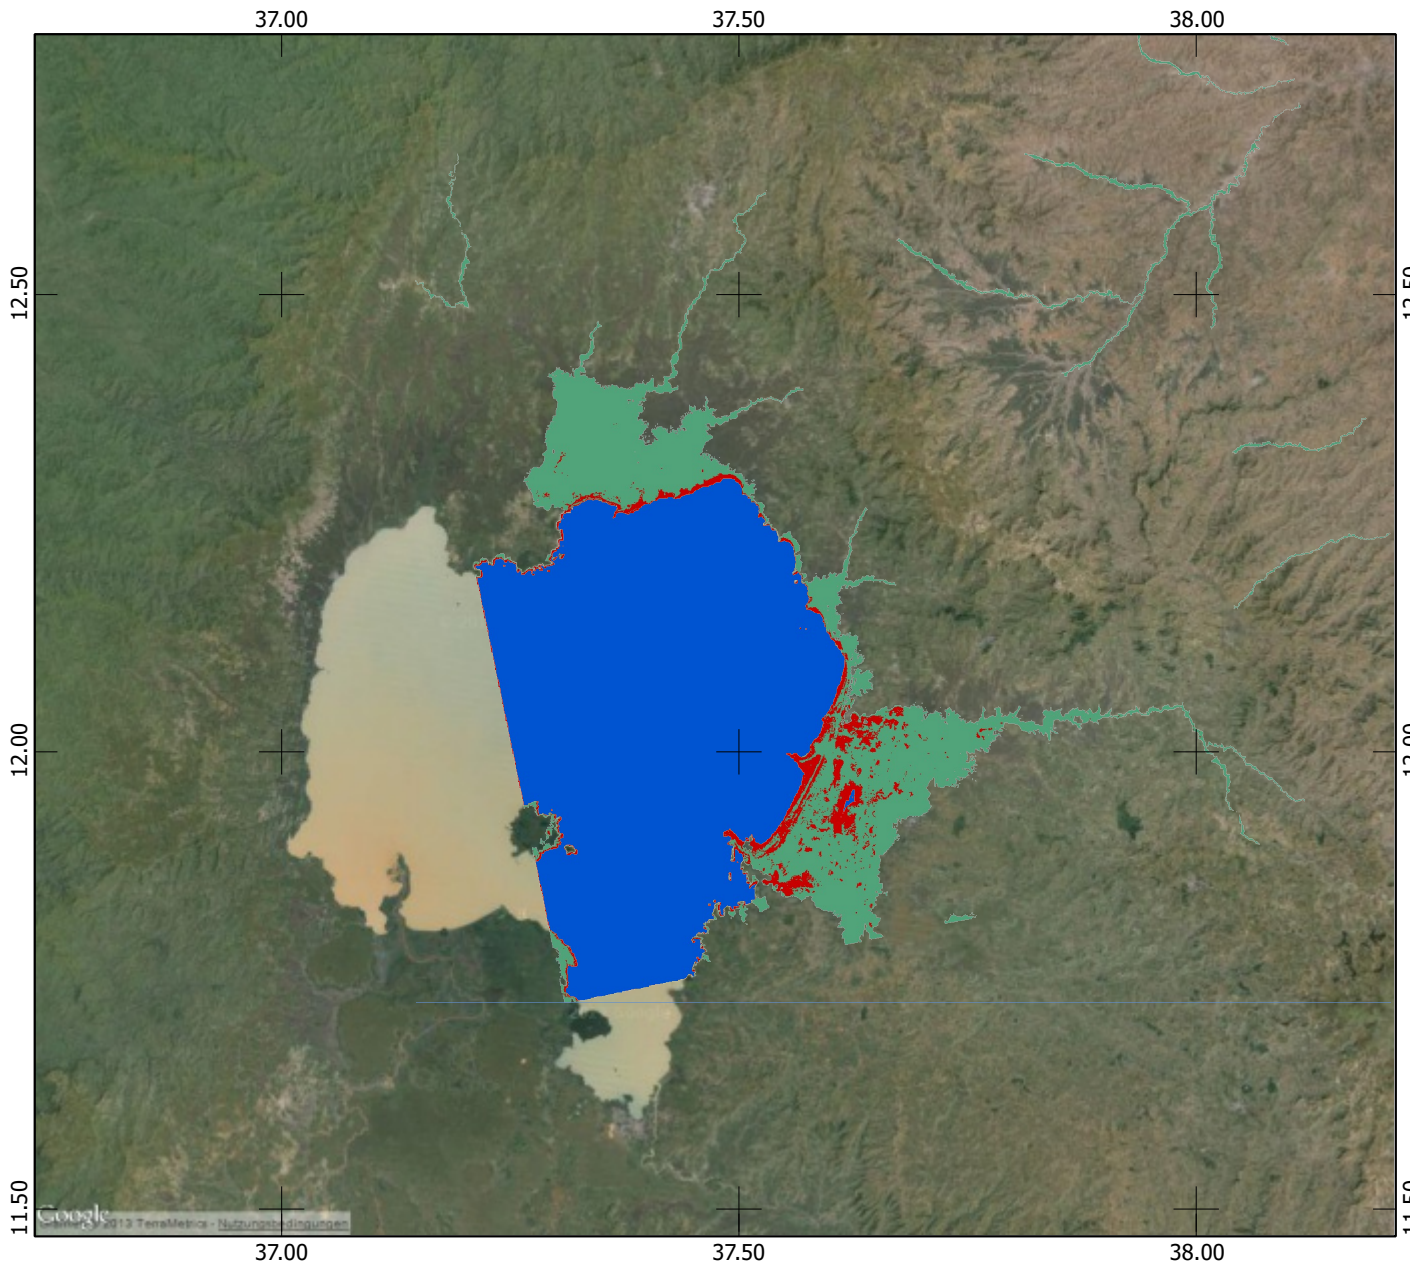
This map shows the flooding situation in the Dembia and Fogera floodplains, north and east of Lake Tana, respectively, on August 18 2013. The flood was delineated with the Water Observation and Information System (WOIS) based on RADARSAT-2 satellite data. The flood map is overlaid on the Google Satellite layer.

RADARSAT-2 Standard beam mode, HH polarisation, 30 m resolution, acquired on Aug. 18 2013, 15:42 (UTC). The RADARSAT-2 product was provided by Canadian Space Agency through SOAR-AF project 5126.
